**Sycamore Creek Drainage Improvements Project**  
**Biological Resources Assessment Report**  
**Phases 1 and 2**

**City of Santa Barbara**  
**Public Works Department**  
**630 Garden Street**  
**Santa Barbara, CA 93101**

**June 2010**

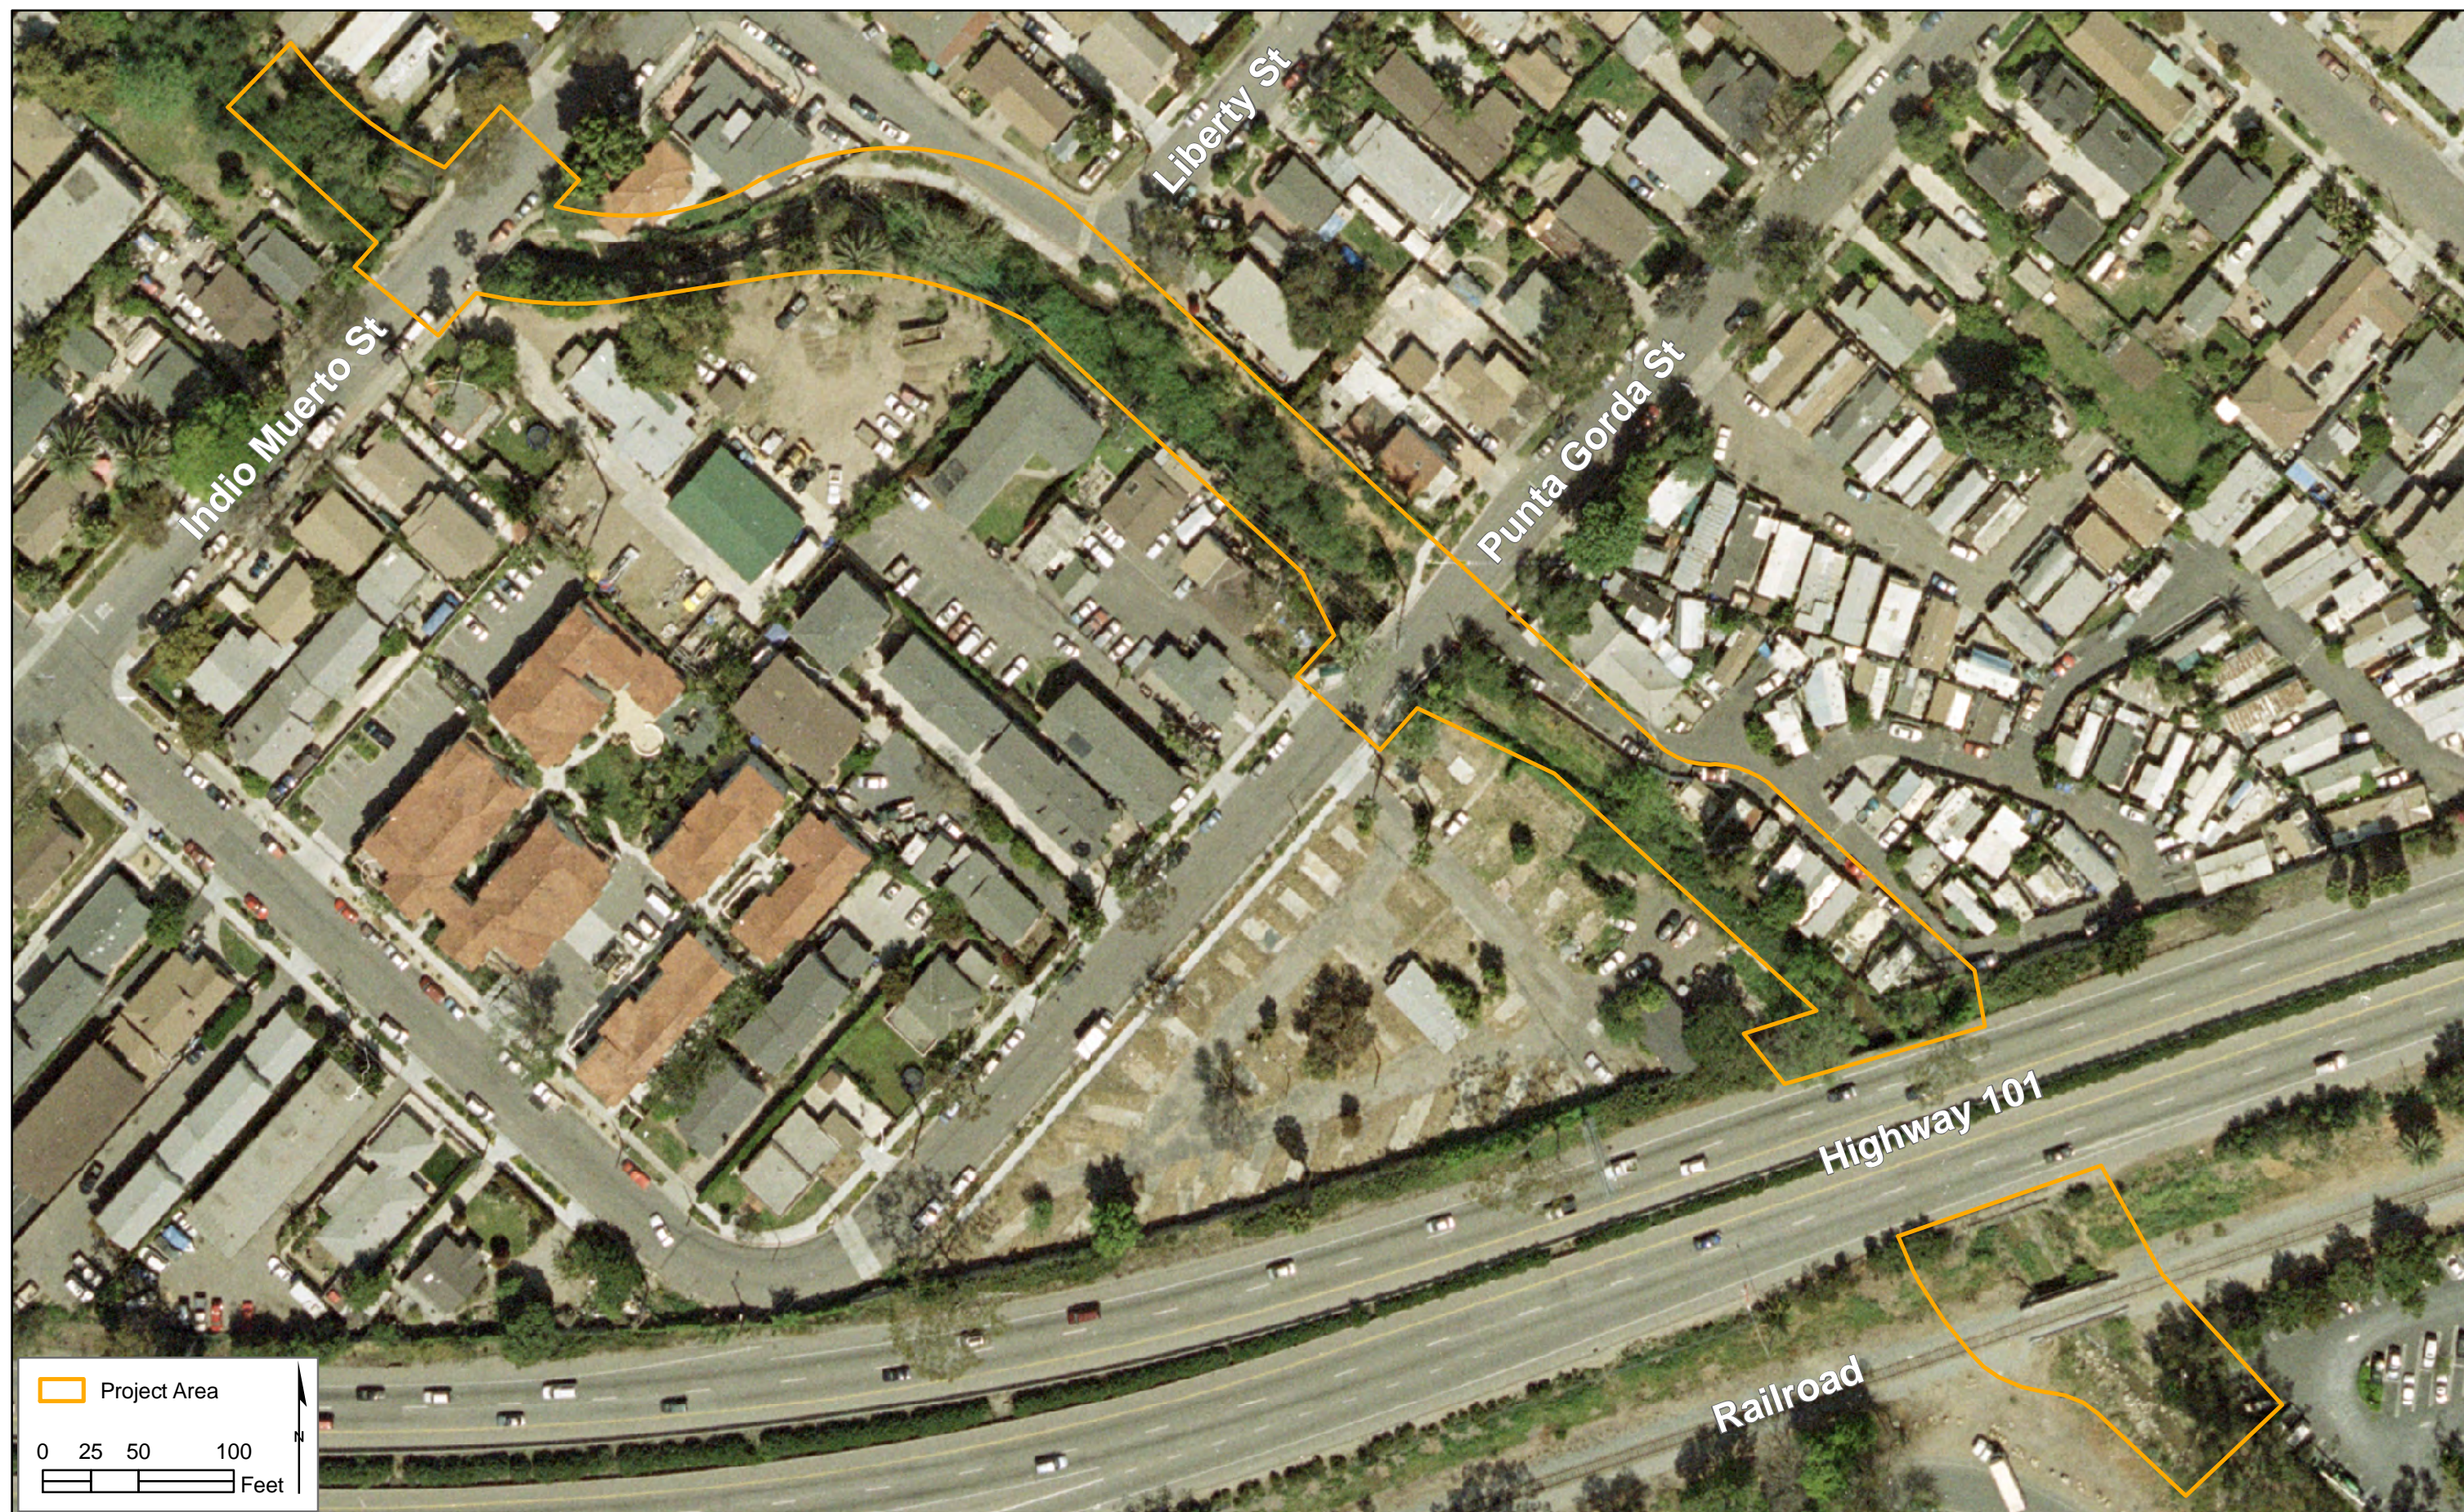
Figure 1. Project Area

The limits of the study area are from 100 feet up stream of the Indio Muerto Street Bridge to 100 feet downstream from the Union Pacific Railroad (UPRR) Bridge (see Figure 1). Most of this portion of Sycamore Creek is approximately 20 feet wide and will have to be widened to approximately 60 feet wide at top of bank. The project will require replacement of the following structures with larger structures: Indio Muerto Street Bridge; Punta Gorda Street Bridge; and UPRR Bridge.

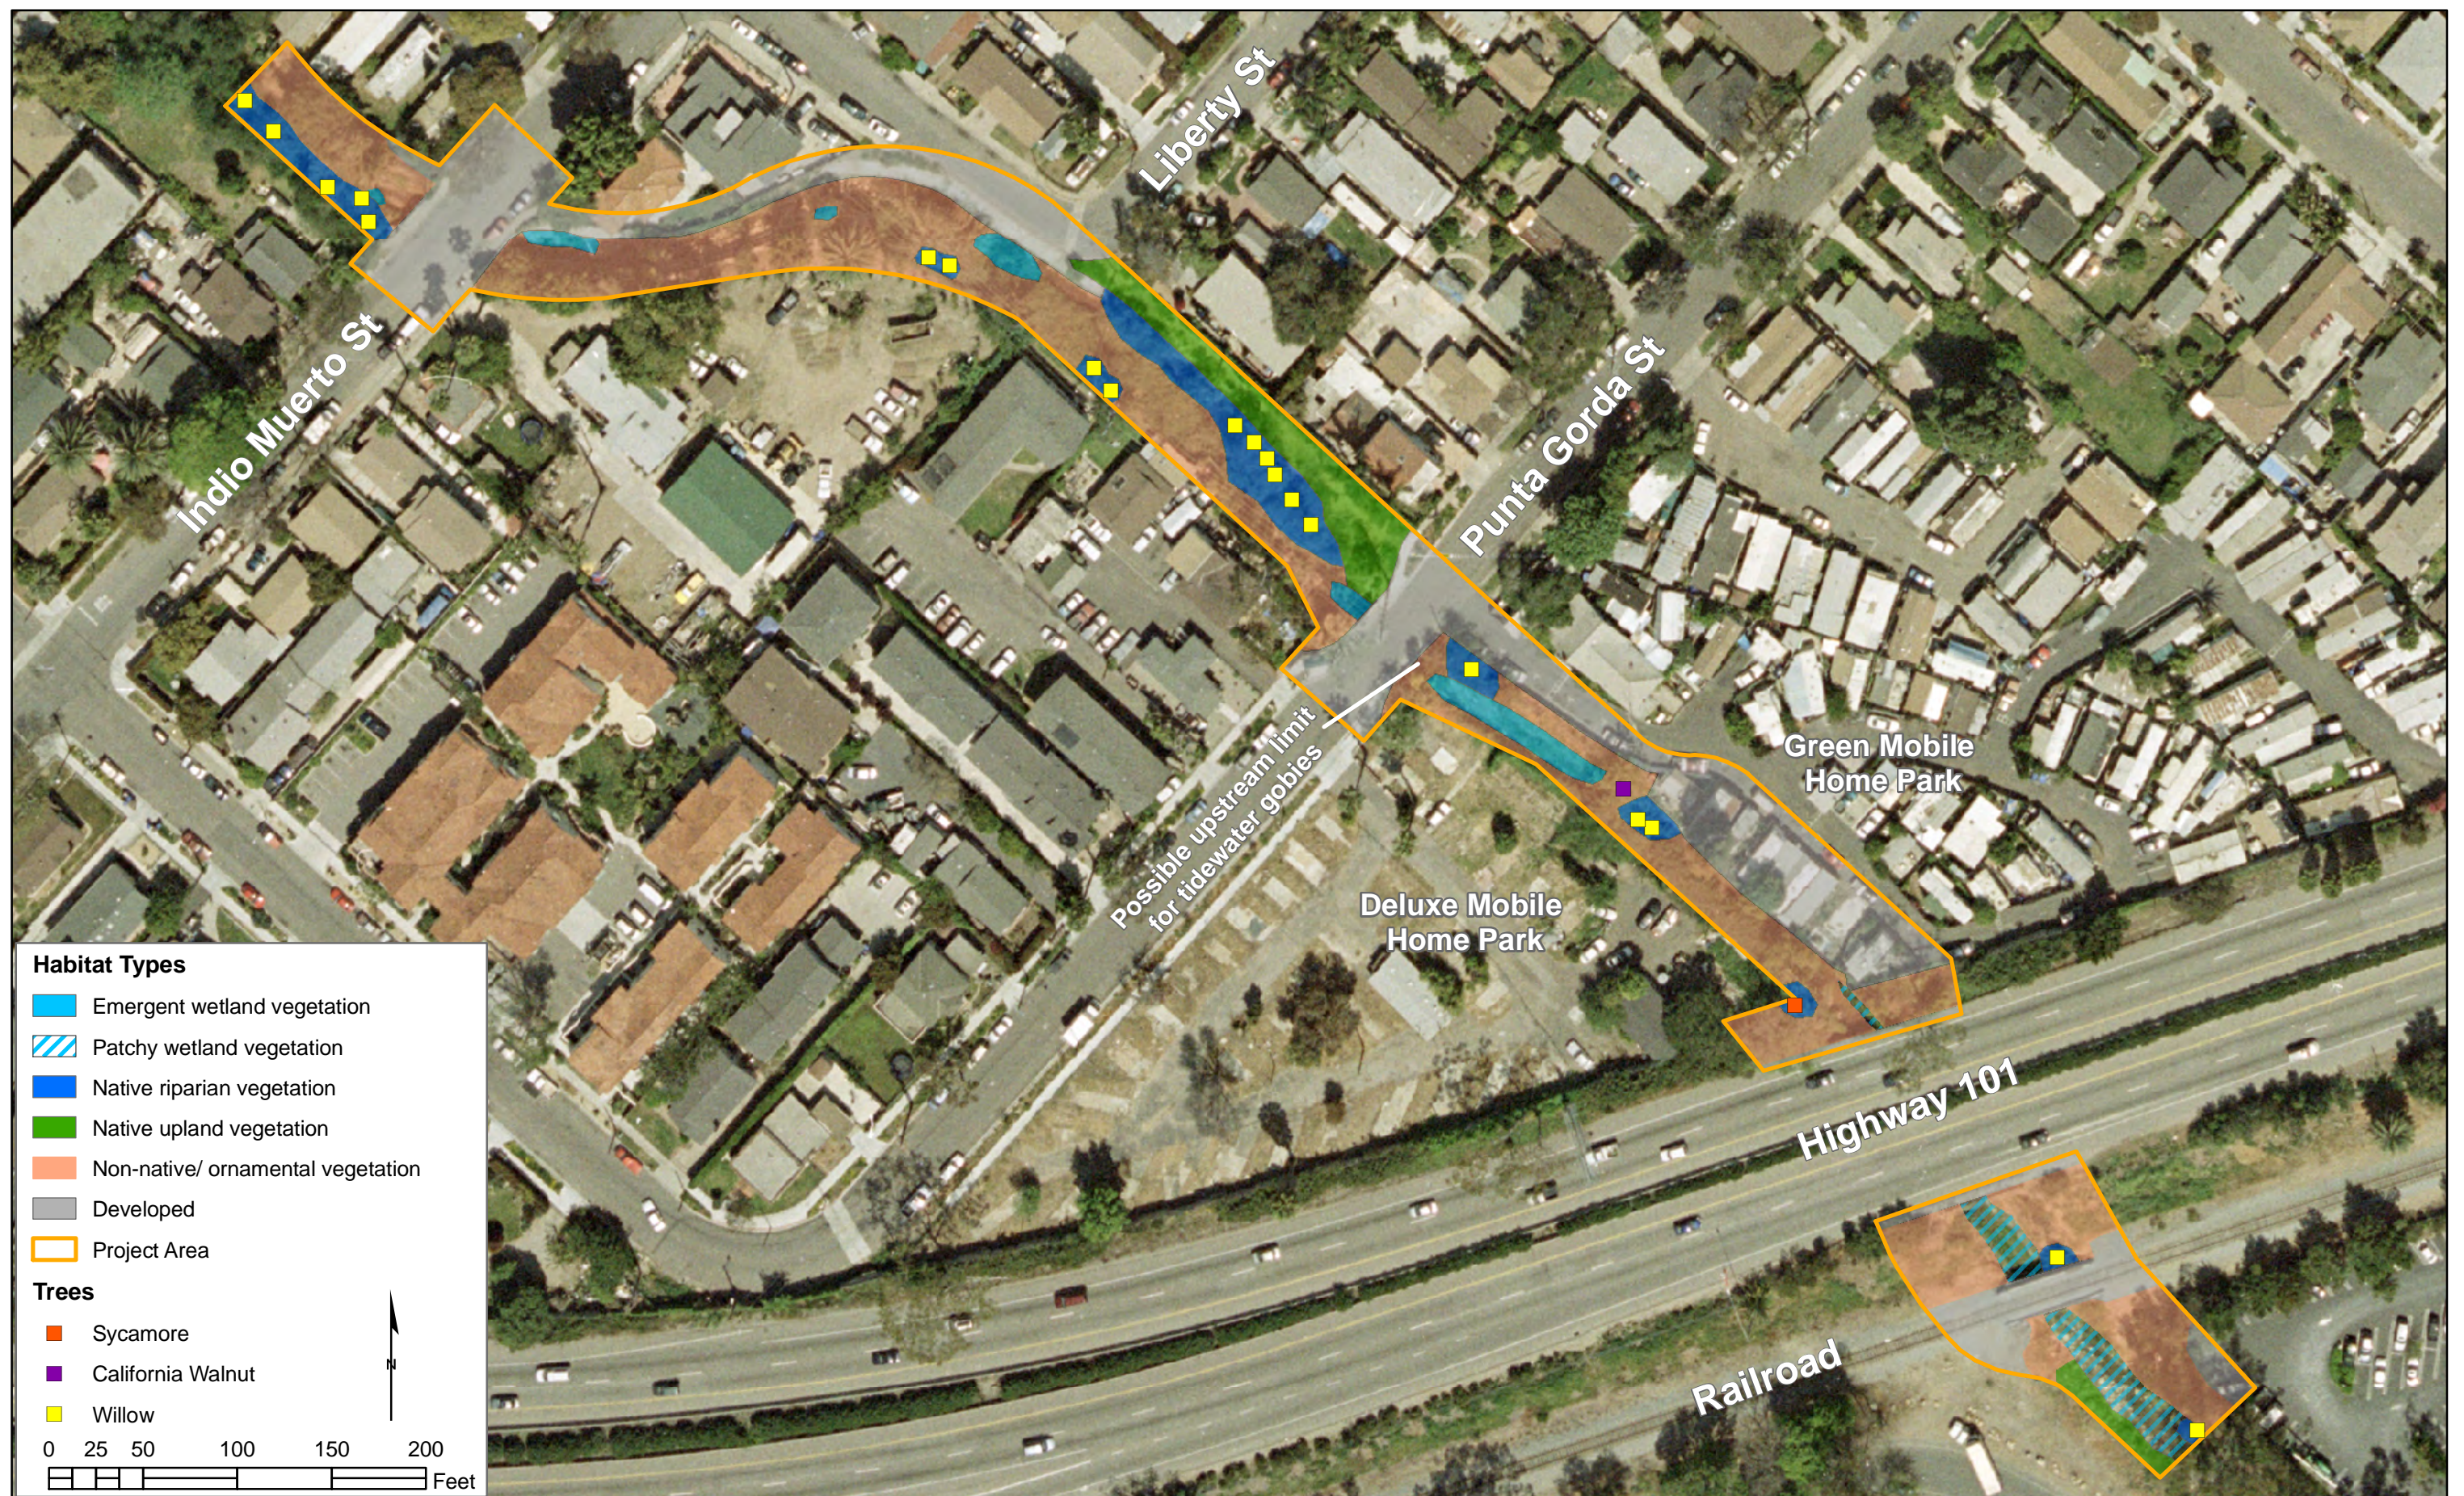
Figure 2. Biologican Resources and Habitat Types along Sycamore Creek

The vegetation along Sycamore Creek comprises a mix of non-native, landscape and ornamental vegetation, and native riparian species. Figure 2 shows the habitat types mapped along the project area and Table 1 lists the areas of each habitat type. A list of species observed in the project area is included in Appendix B. A number of highly invasive non-native species are present and include sticky eupatorium (*Ageratina adenophora*), cape ivy (*Delairea odorata*), giant reed (*Arundo donax*), and castor bean (*Ricinus communis*).

Native riparian vegetation on the habitat map includes those areas dominated by arroyo willow, cottonwood, and western sycamore trees with open to dense riparian understory. Native upland vegetation includes two areas found to be previously restored with planted natives. These areas include the western bank of Sycamore Creek south of the UPRR and the eastern bank between Punta Gorda Street and Liberty Street.

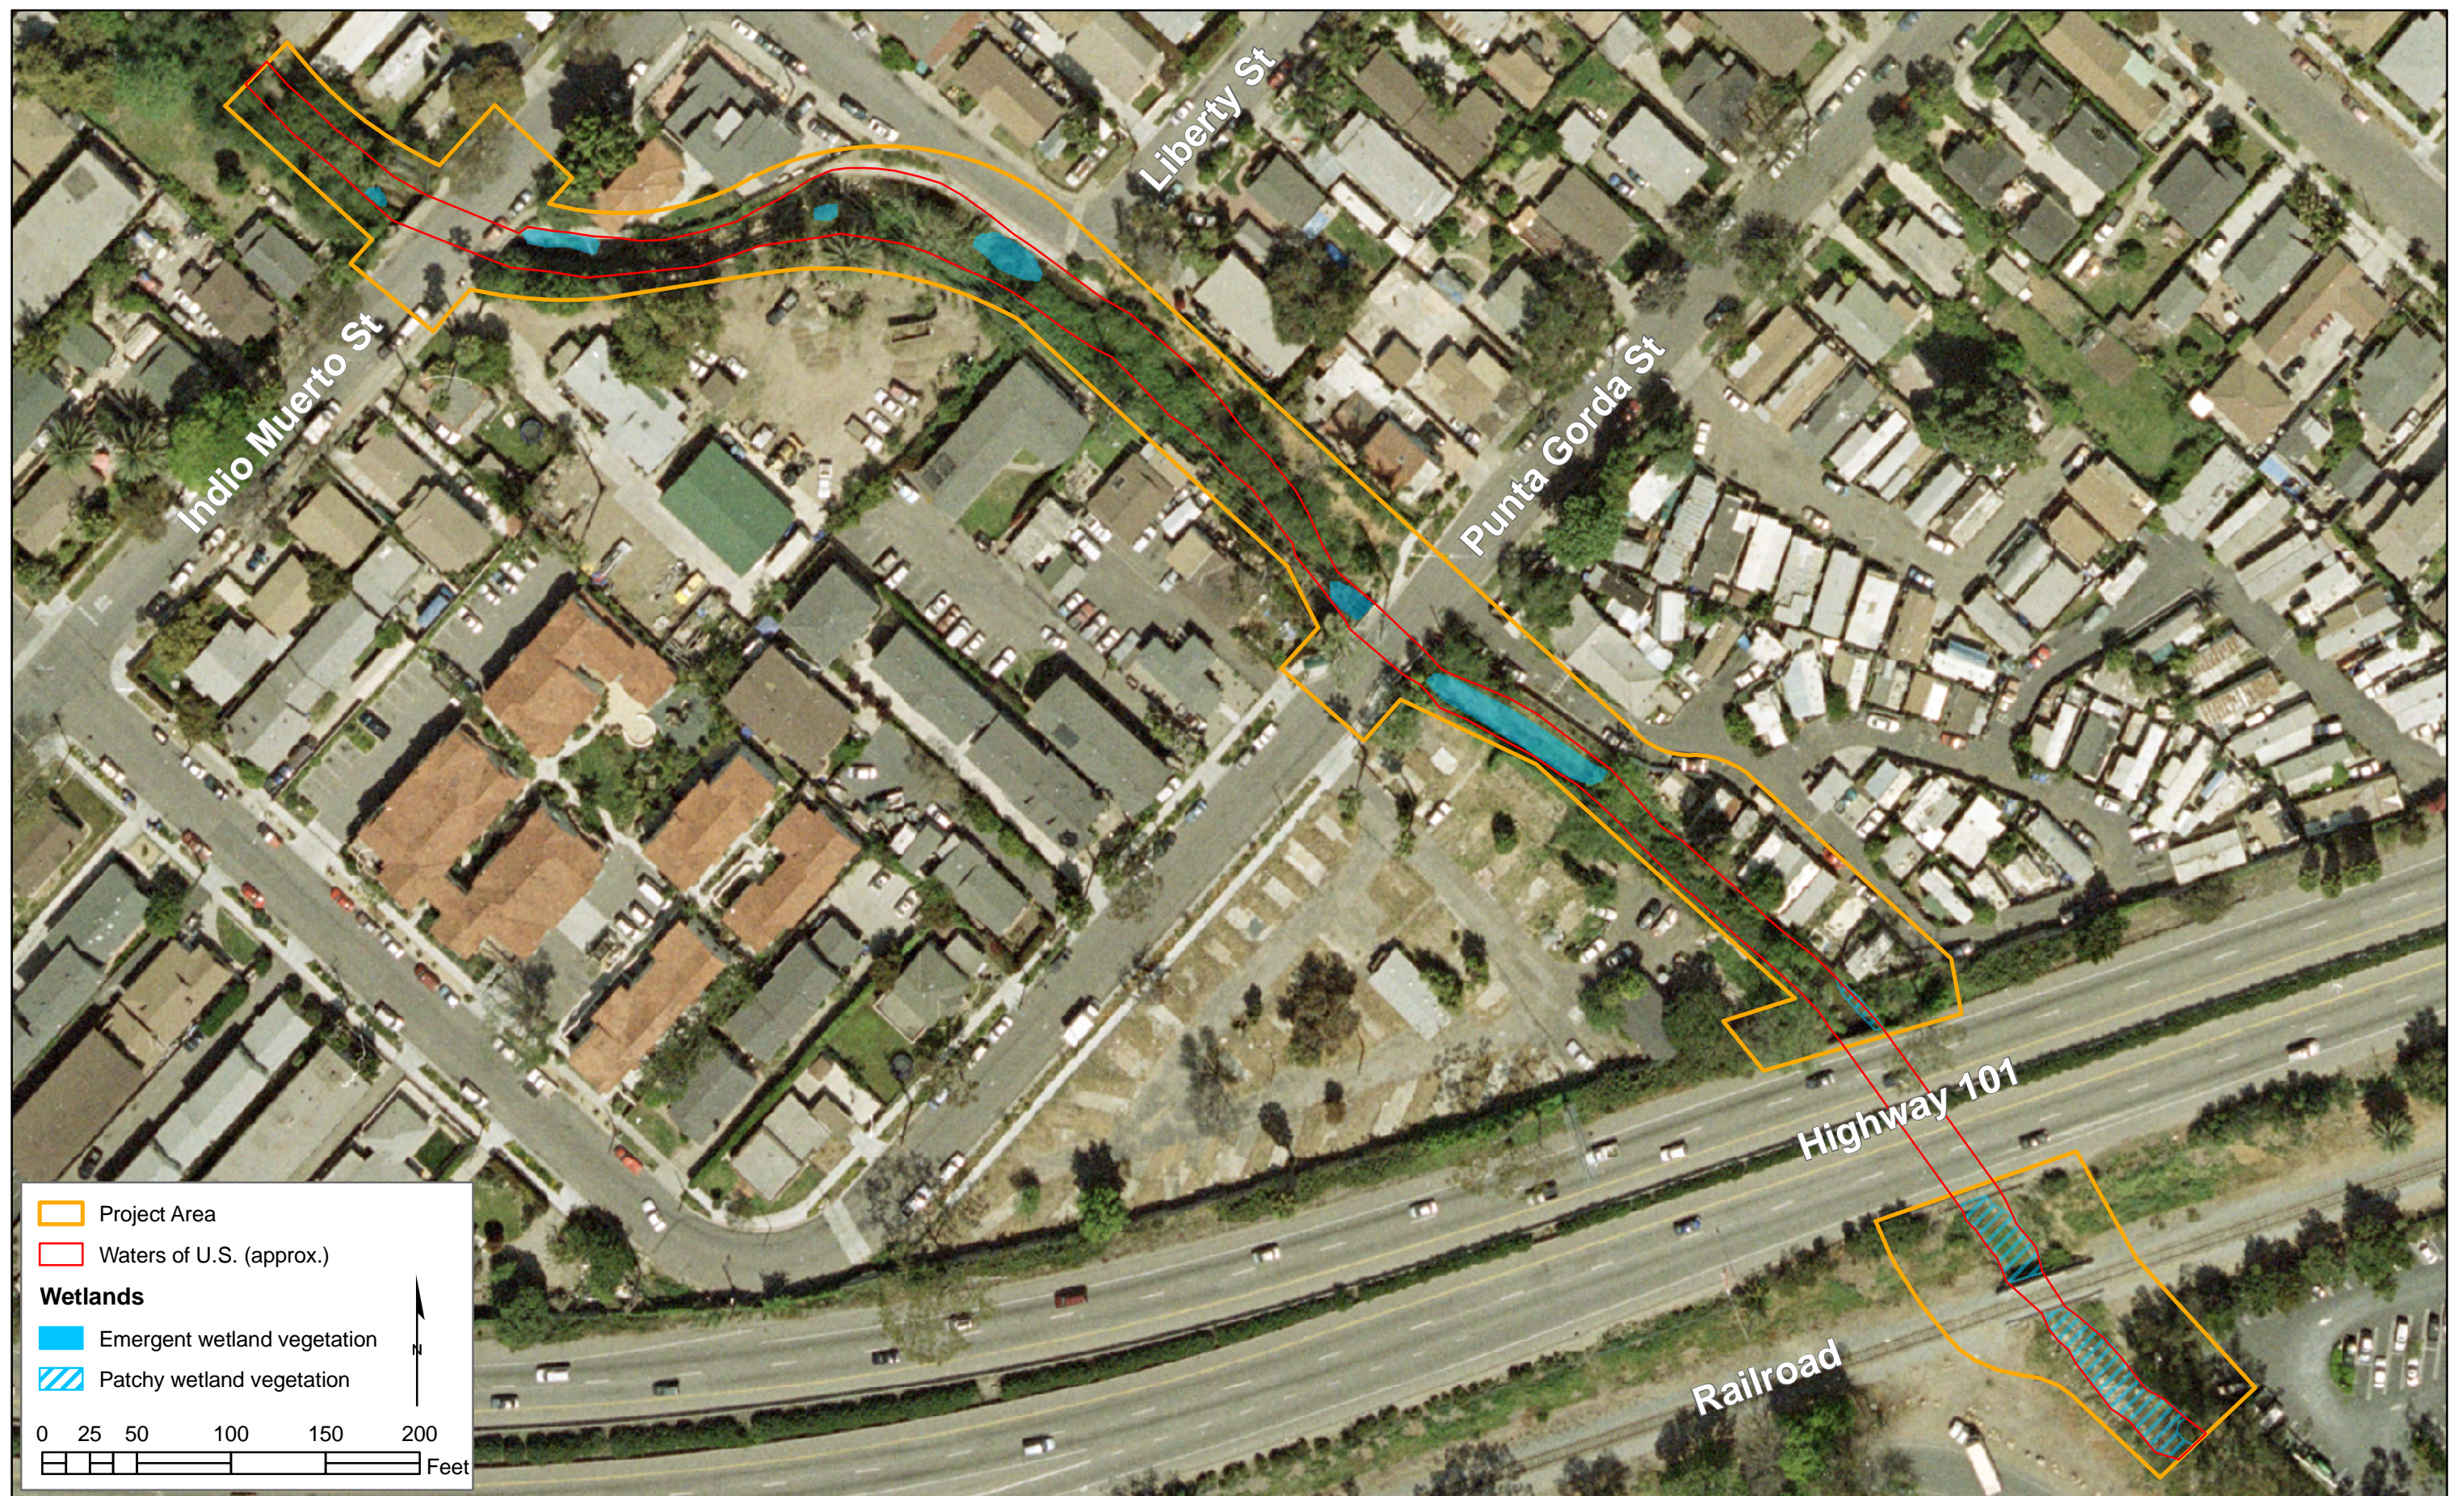
Figure 3. Wetlands and Waters of the U.S. along Sycamore Creek

During construction to widen the channel, the entirety of Waters of the U.S. within each phase would be temporarily disturbed as earth-moving equipment expands and contours the banks and the channel. If flowing water is present during construction, water diversions or dams may be used temporarily to maintain suitable dry working conditions. The bottom elevation of the creek shall remain the same as existing conditions. The completed project would expand Waters of the U.S. in Sycamore Creek from the existing approximate 20-foot width to an approximate width of 60 feet. No permanent loss would occur.

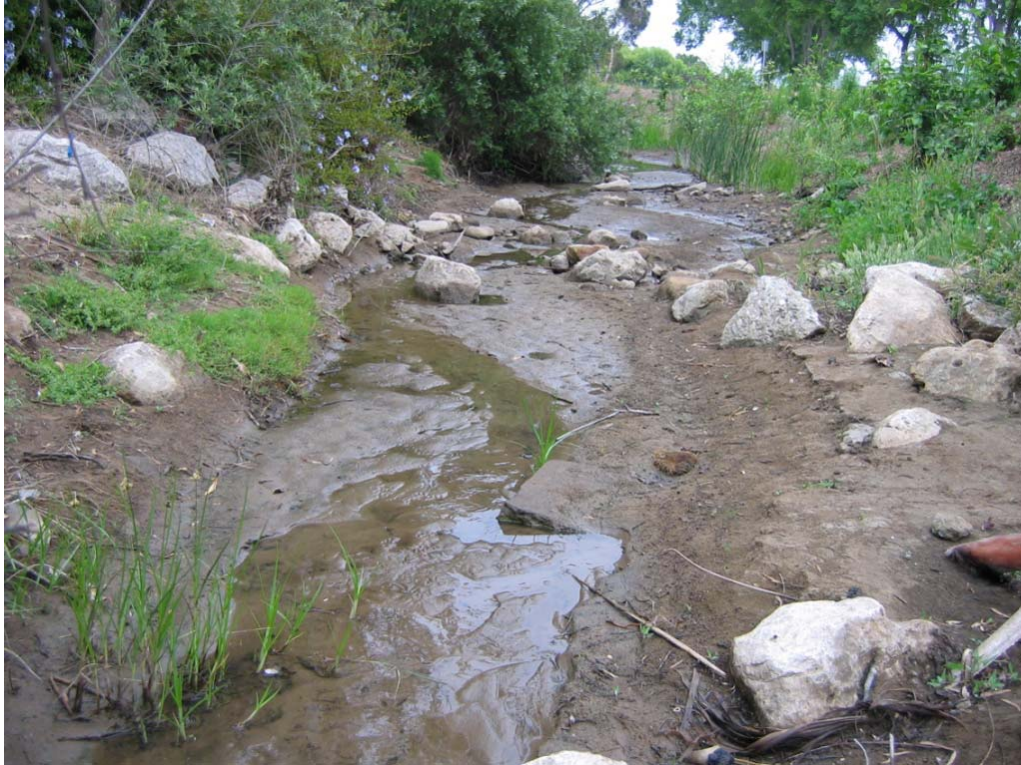
Scattered wetland vegetation south of Union Pacific Railroad Bridge (UPRR), looking downstream.

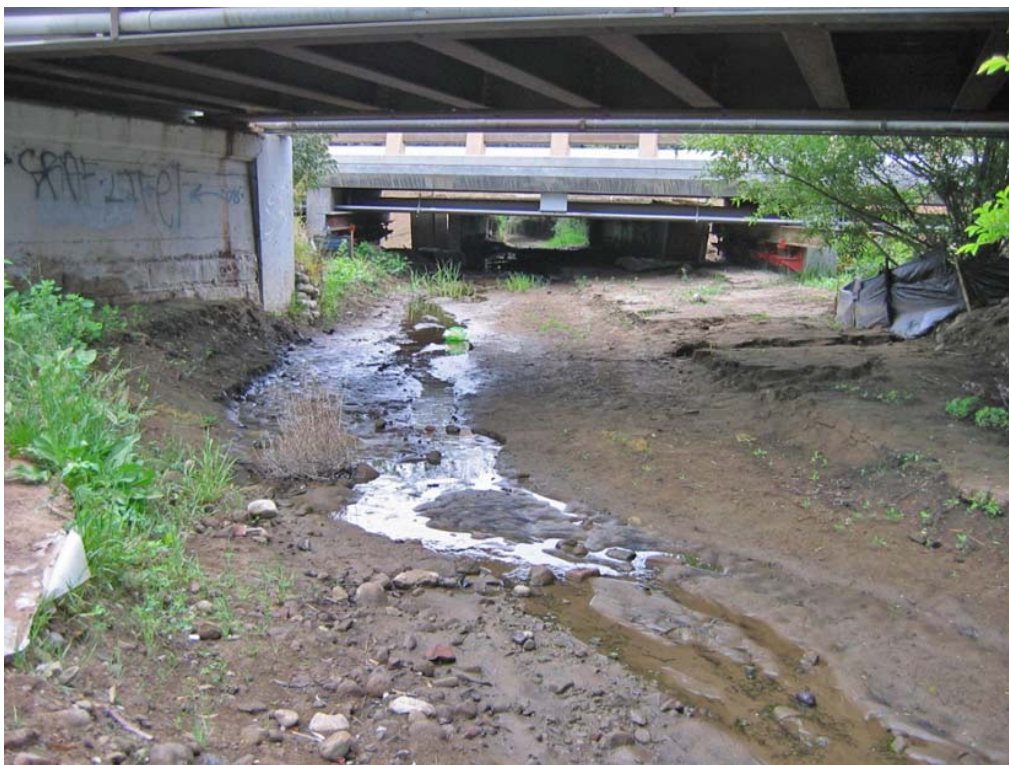
At Union Pacific Railroad, looking upstream under UPRR Bridge and Highway 101 Bridge.

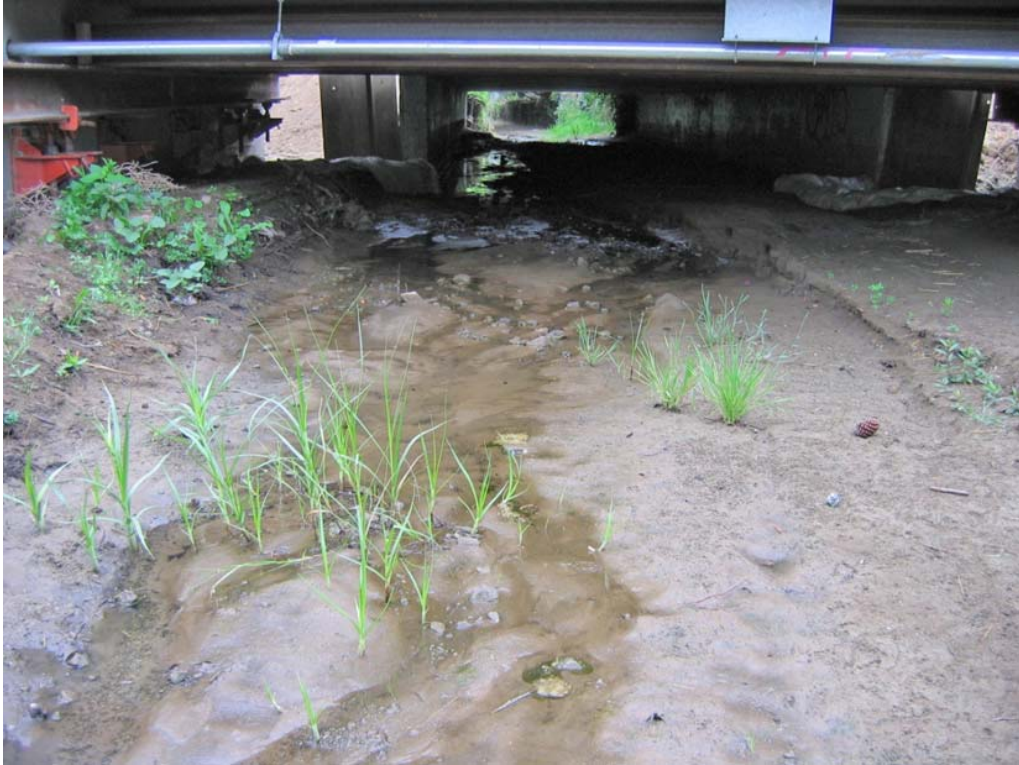
Scattered wetland vegetation in the creek bed between UPRR Bridge and Highway 101 Bridge.

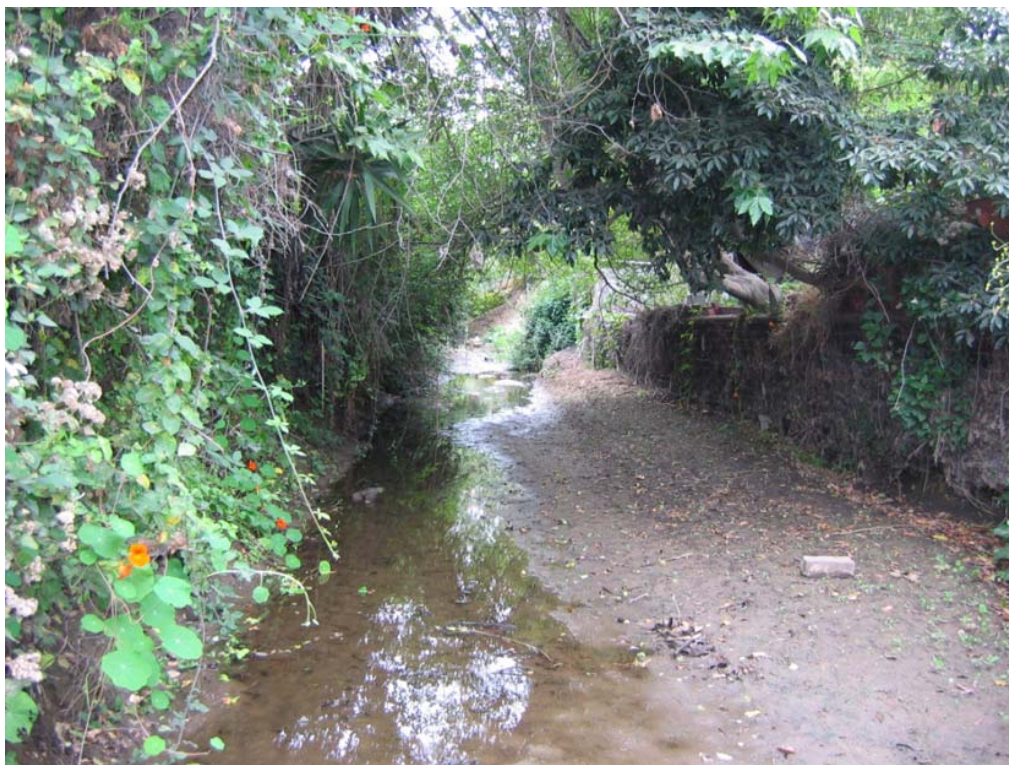
Stream corridor north of Highway 101 Bridge, looking upstream. Pipe and wire revetment is visible on the east (right) bank.

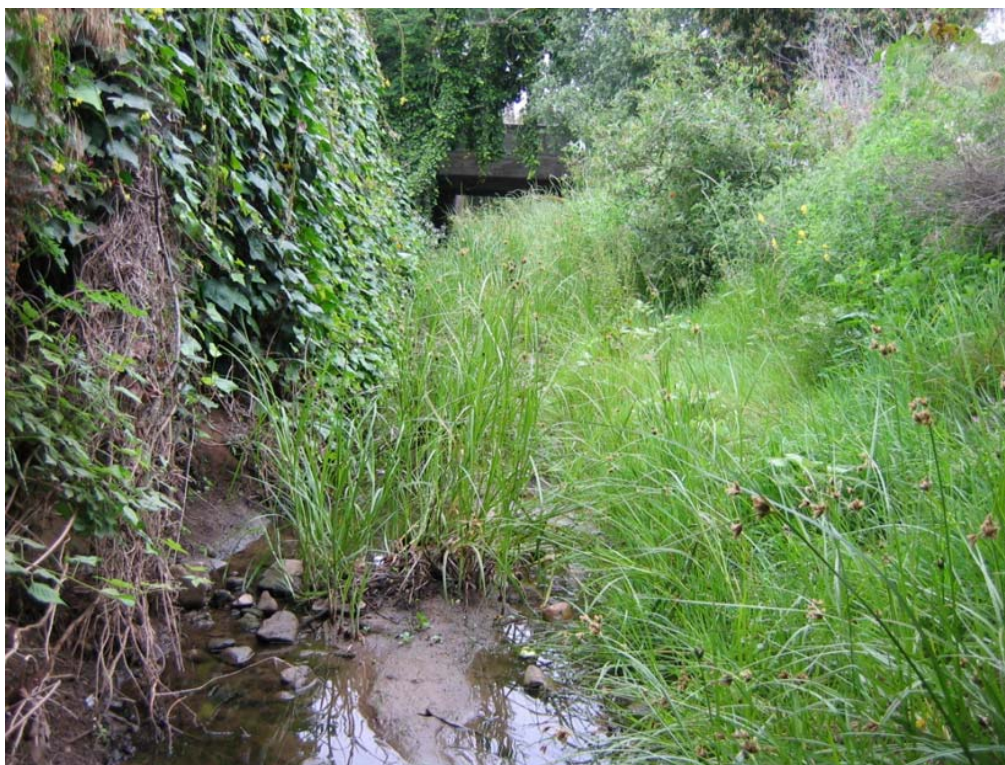
Stream channel with wetland vegetation, looking upstream towards Punta Gorda Street Bridge. Left bank has pipe and wire revetement and right bank is earthen.

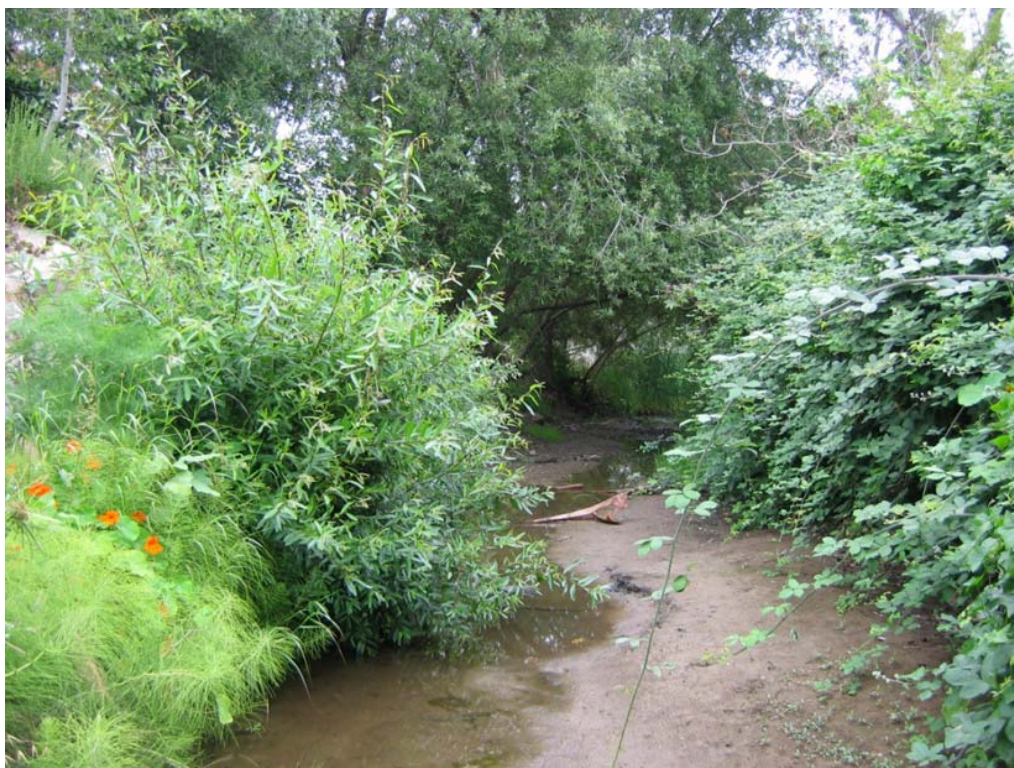
Santa Barbara Flood Control regularly clears vegetation from the creek to maintain optimal flows during high rainfall years. Evidence of this maintenance was observed in May 2009 with several willow stumps beginning to resprout between Punta Gorda Street and Liberty Street.

Mature (left background) and resprouting (left foreground) willows and wetland vegetation, looking downstream from hear Liberty Street.

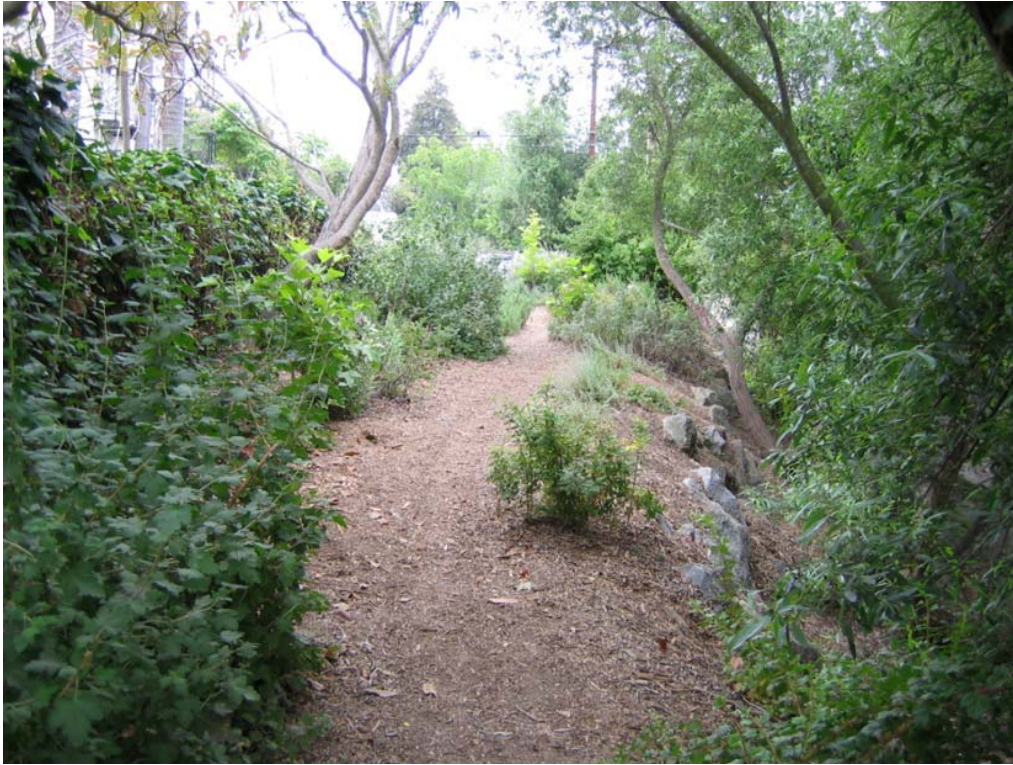
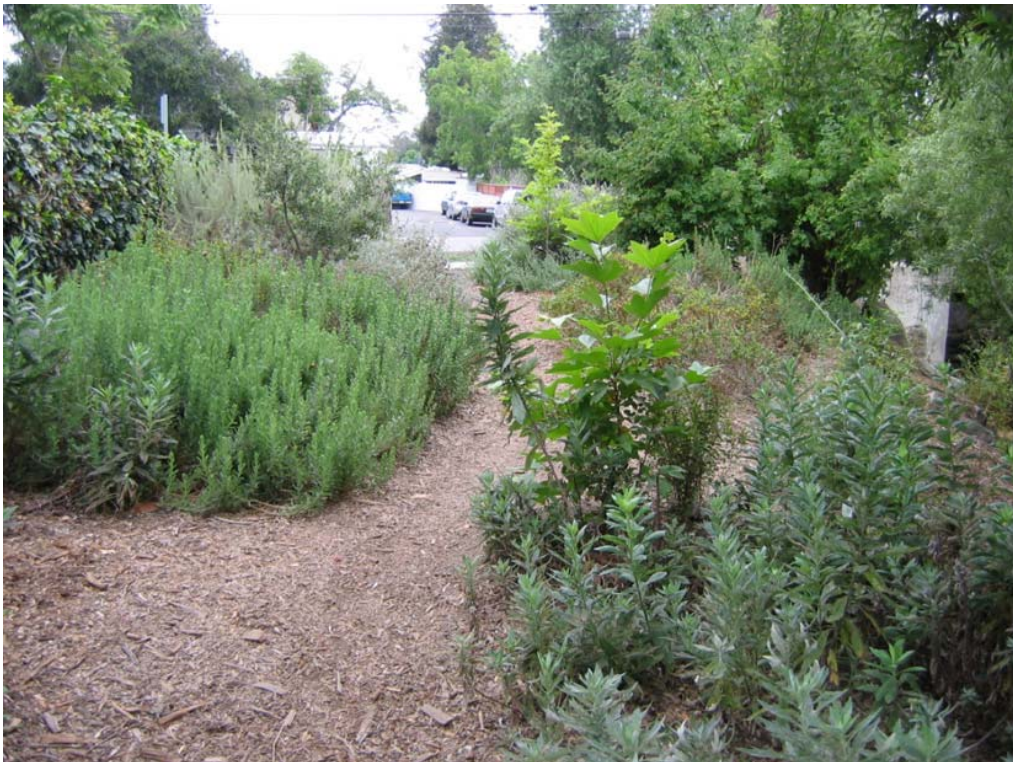
Native upland vegetation restoration area with path along east bank between Liberty Street and Punta Gorda Street.

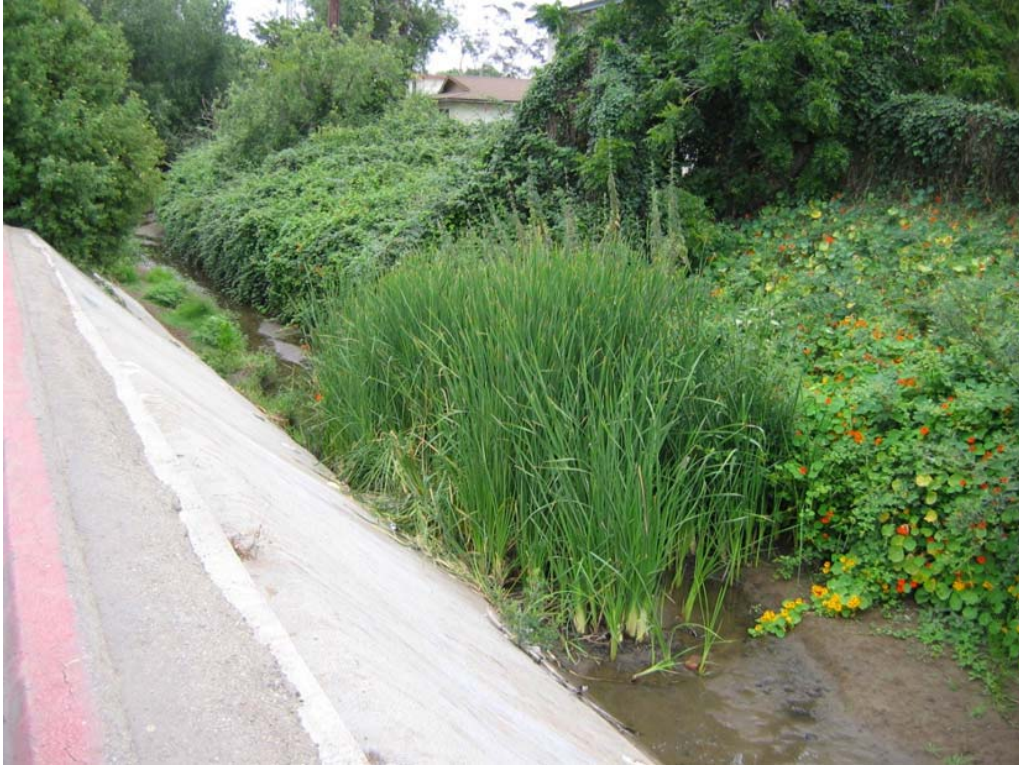
Wetland vegetation in channel (primarily cattails), looking downstream from Liberty Street concrete embankment.

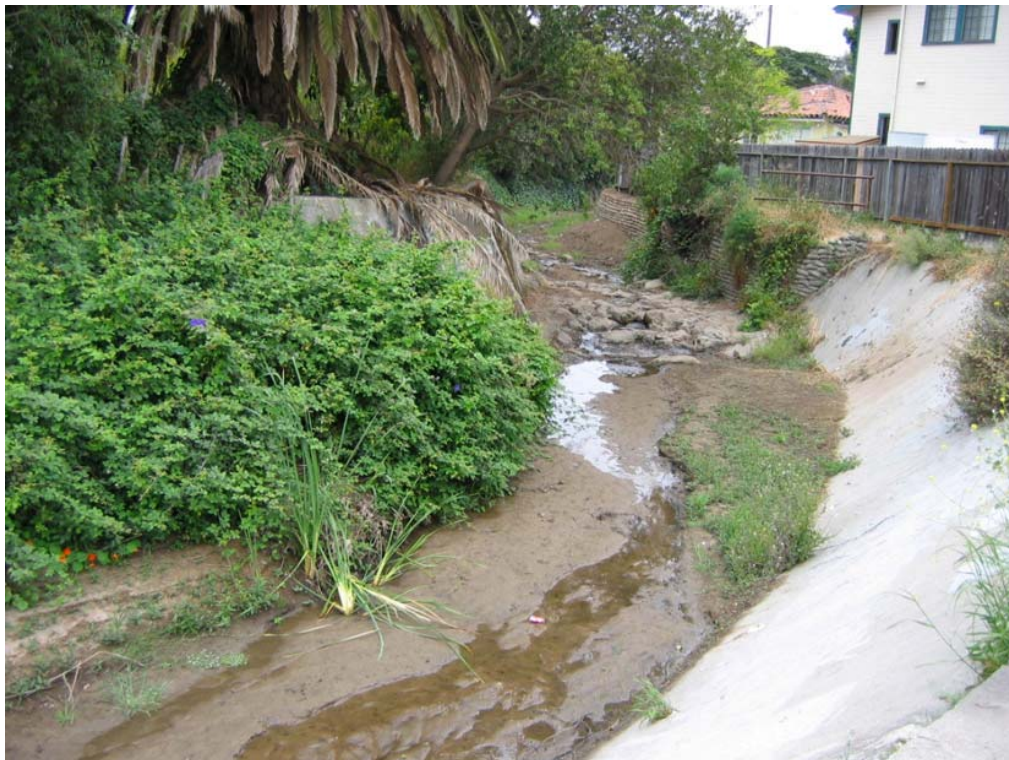
Wetland vegetation (primarily willow seedlings on bar against concrete, looking upstream at Liberty Street concrete embankment. Grouted rock is in channel bed adjacent to concrete bank on left.

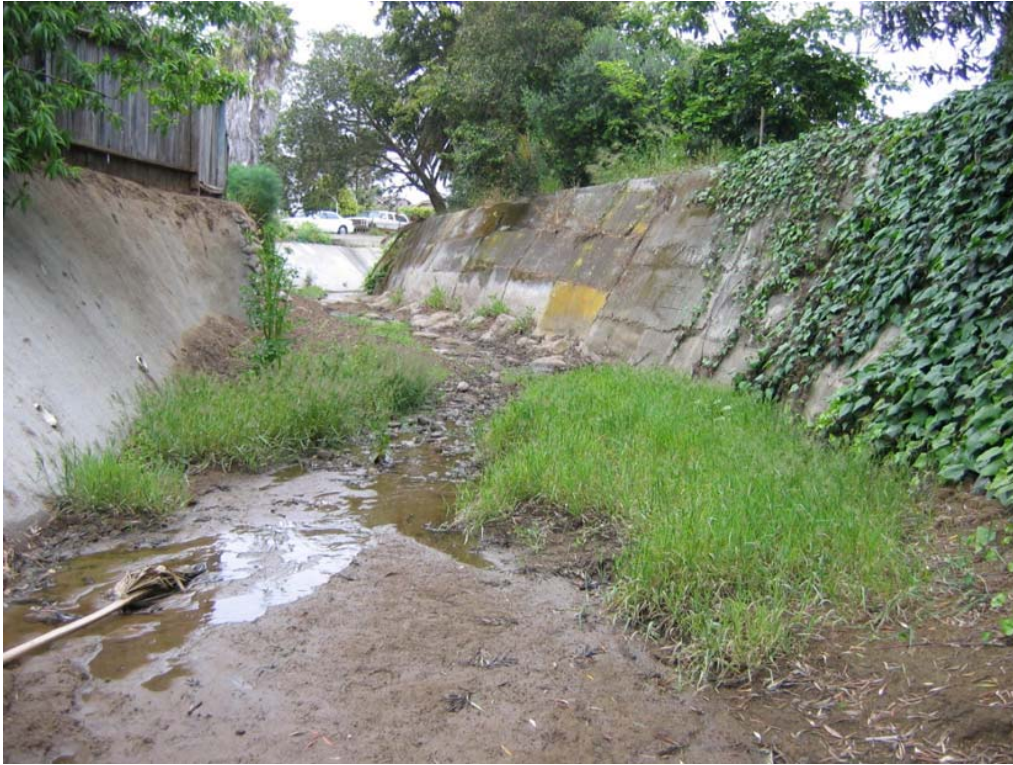
Stream channel looking upstream between Liberty Street and Indio Muerto Street.

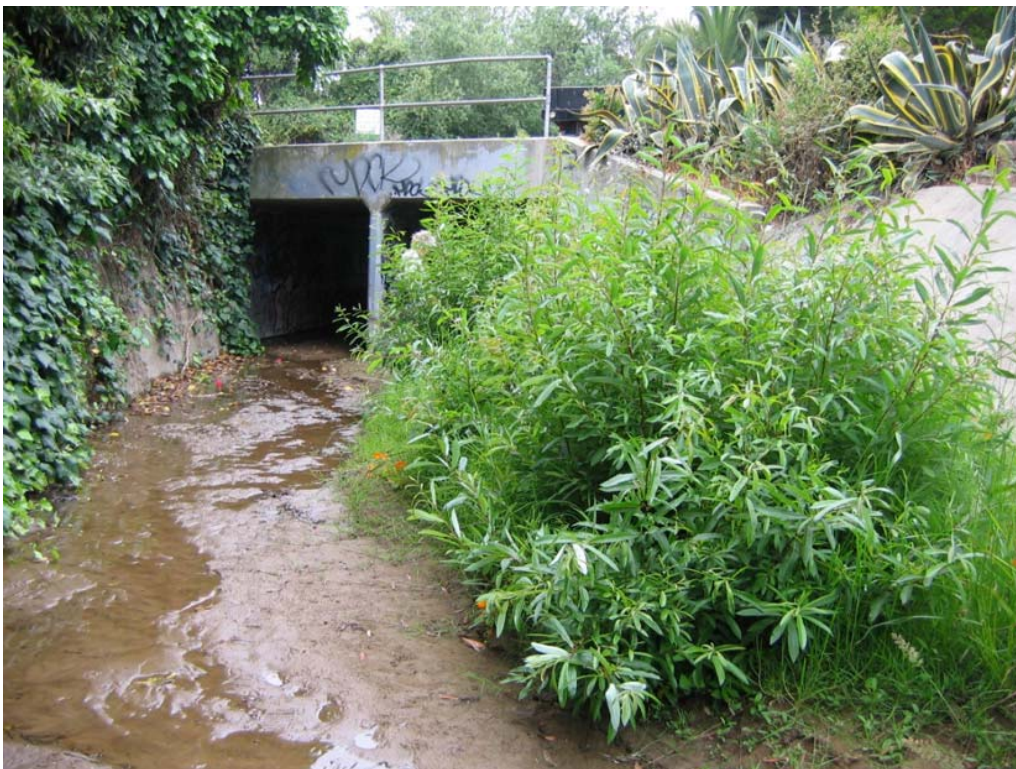
Wetland vegetation in stream channel (right side), looking upstream towards Indio Muerto Street Bridge.

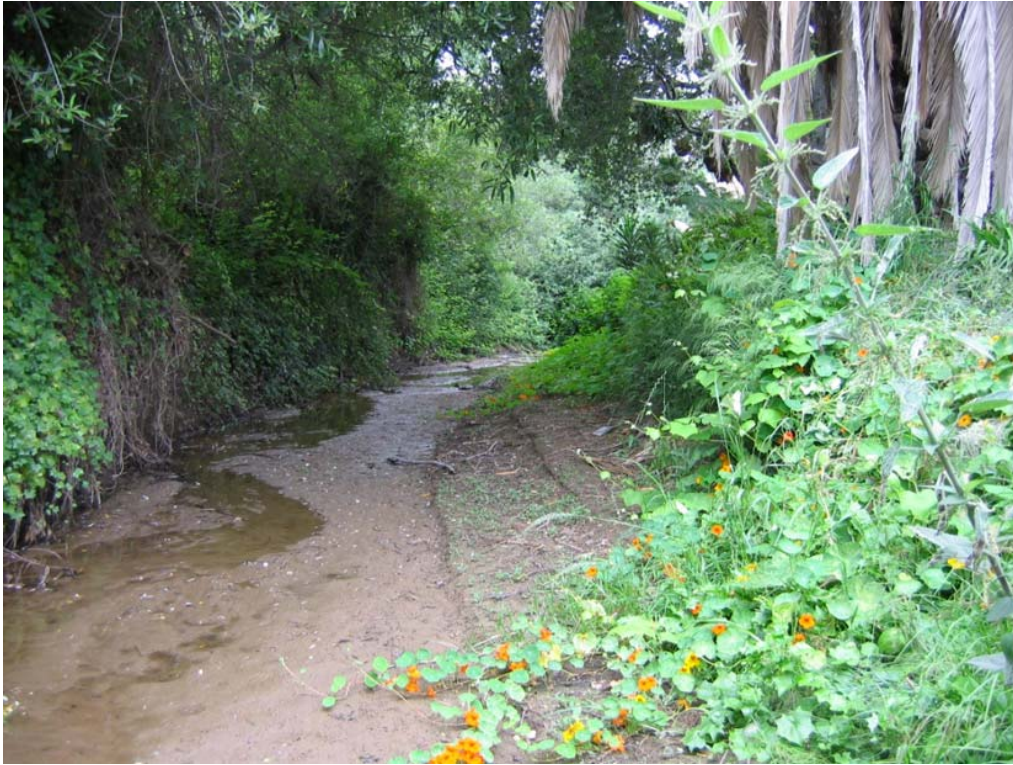
Stream channel north of Indio Muerto Street Bridge, looking upstream. Vegetation on banks is primarily landscape species. Several large willow trees are present at the top of the left bank.
